Intel[®] Pentium[®] III Processor Specification Update

Release Date: February 2005

Document Number: 244453-052

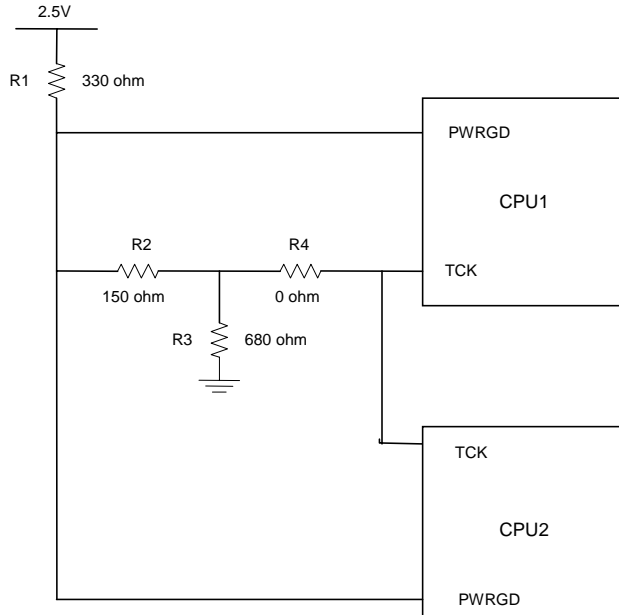
Pentium® III Processor with 512KB L2 Cache Platforms Workaround

Assumes the inputs to the CPU_PWRGD are open collector signals that are Wire-ANDed together

- The example workaround circuit assumes that the PWRGD inputs into the processors are open collector. Tying the PWRGD inputs together in a Wired-AND fashion allows each processor to receive PWRGD at the same time but at the latter of the 2 separate PWRGD assertions. If separation of the PWRGD inputs to each processor is required, extra circuitry will be required.
